# LAWRENCE TECHNOLOGICAL UNIVERSITY

## INSPECTION AND DETERIORATION OF BRIDGE DECKS CONSTRUCTED USING STAY-IN-PLACE METAL FORMS AND EPOXY-COATED REINFORCEMENT

Testing and Research Section  
Construction and Technology Division  
Contract # 2002-0134

**October, 2004**

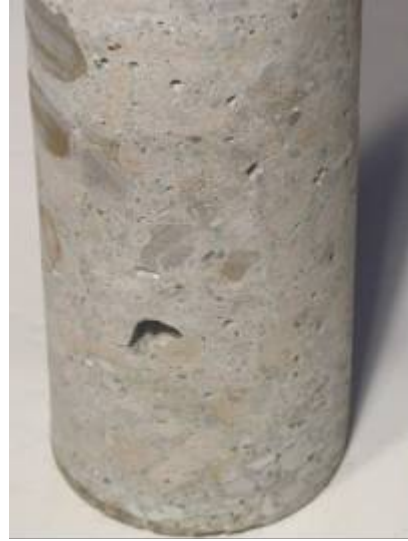
- 12.5 in. height.
- The concrete in the region of the valley of the SIPMF was broken during coring.
- Three longitudinal cuts through steel reinforcement bar located 5.5 and 6.5 in. from the top were observed.
- Two regions of honeycombing of average diameter 0.6 in. were observed at 3.5 and 9.5 in. from the top surface.
- One bar had minor rust traces while the others did not.
- The reinforcement bars were epoxy coated.
- SIPMF was separated from the concrete.
- The connection between the concrete and the bracing angle had traces of rust.

Figure 3.133. Core 8a honeycombing and large single void in the concrete

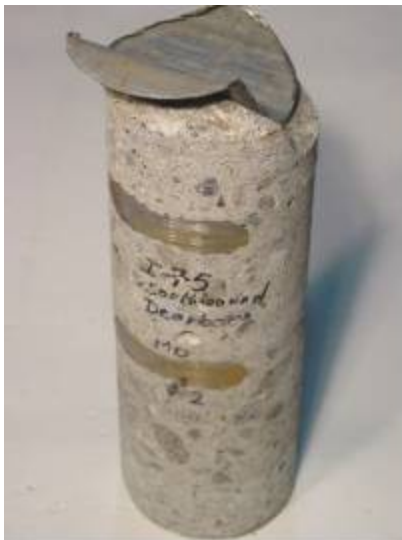
**Core 8b** (Figure 3.134)

- 9.5 in. height (11.6 in. with the concrete in the region of the valley of the SIPMF).
- The concrete in the region of the valley of the SIPMF was broken during coring.
- Two longitudinal cuts in the reinforcement located 5.0 in. and 8.5 in. from top.
- One region of honeycombing of approximate width of 0.4 in. located 5.5 in. from top.
- Two large voids of average diameter 0.5 in. located 5.0 in. and 7.5 in. from top.
- The wearing surface had very high porosity and many voids of average diameter 0.3 in.
- SIPMF was separated.
- Steel reinforcement bars were in good condition.

a. Rust traces

Figure 3.134. Core 8b with large region of voids and rust in the reinforcement bars

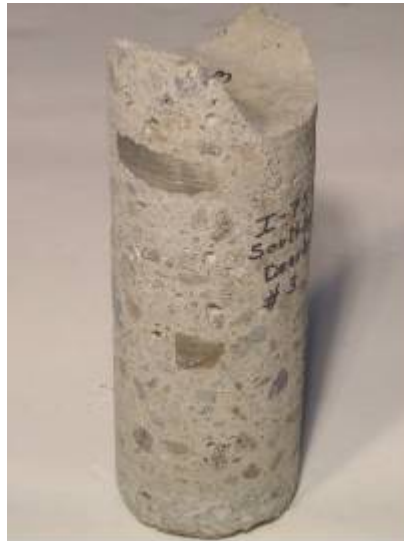
**Core 8c** (Figure 3.135)

- 9.0 in. height (10.5 in. with the concrete in the region of the valley of the SIPMF).
- The concrete in the region of the valley of the SIPMF was partially broken during the coring.
- Three longitudinal cuts in the reinforcement located 4.5, 6.5, and 8.3 in. from top.
- Large entrapped air voids of average diameter 0.3 in. located 5.0, 5.5, 5.8, and 6.0 in. from top were observed.
- SIPMF separated from the core.
- Slag was used as aggregates; and cement paste had high porosity.
- The wearing surface had higher porosity and more voids.
- Steel reinforcement bars were in good condition.

Figure 3.135. Core 8c

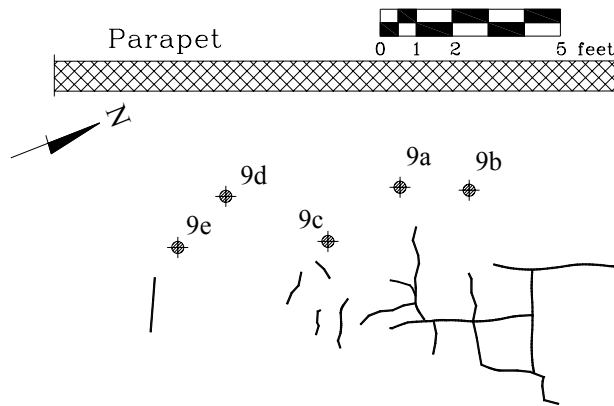
Detail 9

Figure 3.141. Map of cracks at coring locations for Bridge Deck Number 9 (Structure No. S10-82022)

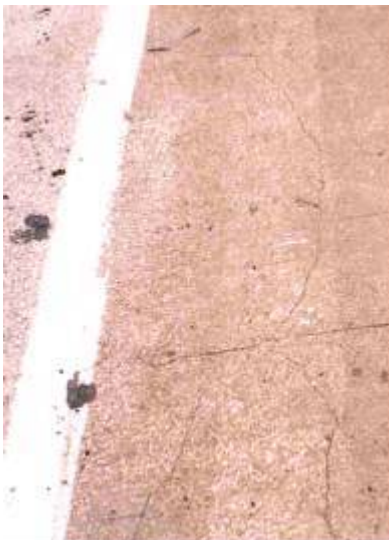
The top and bottom surfaces of the deck slab were visually inspected. Propagated cracks were observed at the top surface of the concrete slab as shown in Figure 3.142. Corrosion in the steel forms was observed near the northeast abutment, at the connection between steel beams and the form and around the concrete in the region of the valley of the SIPMFs (Figure 3.143). In some specific regions corrosion was so excessive that the steel forms were completely damaged and the concrete was exposed as shown in Figure 3.144. White traces and rust traces were seen on the side of the edge beam as shown in Figure 3.145.

Figure 3.142. Cracks at the top surface

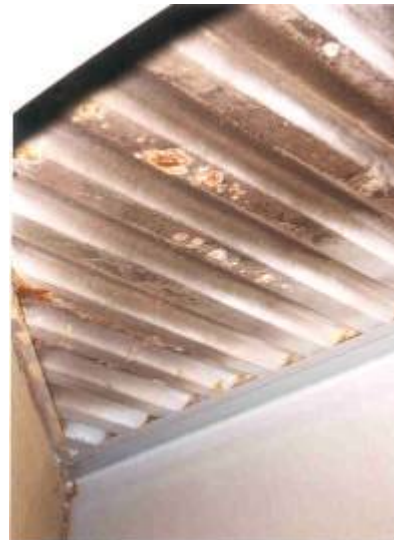
Figure 3.143. Traces of corrosion in SIPMF

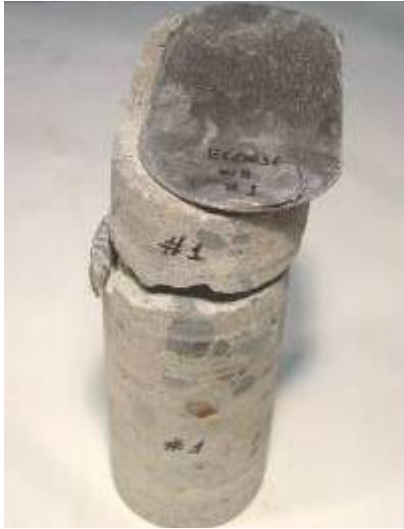
### **Core 9a** (Figures 3.147-3.148)

- 9.7 in. height (11.3 in. with the concrete in the region of the valley of the SIPMF)
- Core fractured at the bottom steel reinforcement located approximately 7.5 in. from top.
- Axial section of a steel bar located 3.8 in. from top showed traces of rust.
- The SIPMF separated from the concrete.

Figure 3.147. Core 9a fractured at reinforcement location

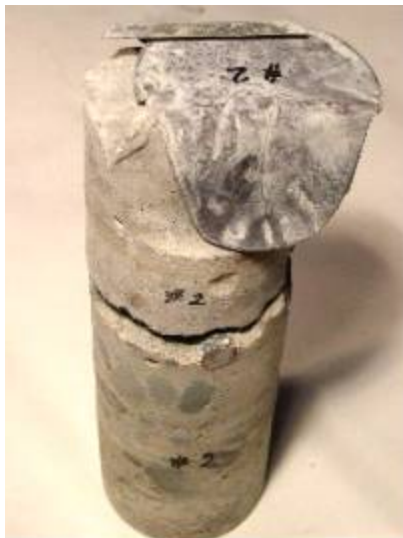
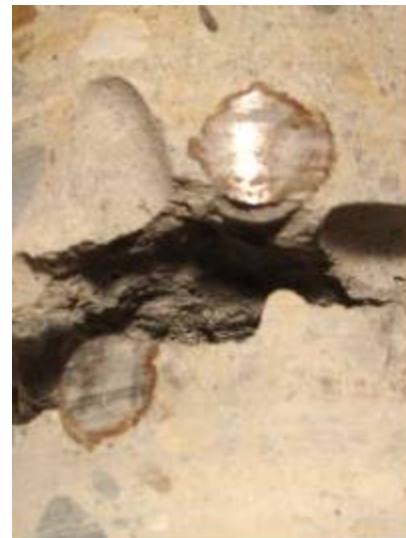
#### Core 9b (Figure 3.149)

- 9.3 in. height (11.3 in. with the concrete in the region of the valley of the SIPMF).
- Core broke at the bottom steel reinforcement located approximately 7.5 in. from top.
- Axial section of a steel bar located 3.8 in. from top showed traces of rust.
- The SIPMF separated from the concrete and consisted of two overlapping parts.
- The reinforcing steel had rust traces on its boundary.

a. Broken at reinforcement location

b. Rust in the reinforcing steel

Figure 3.149. Core 9b

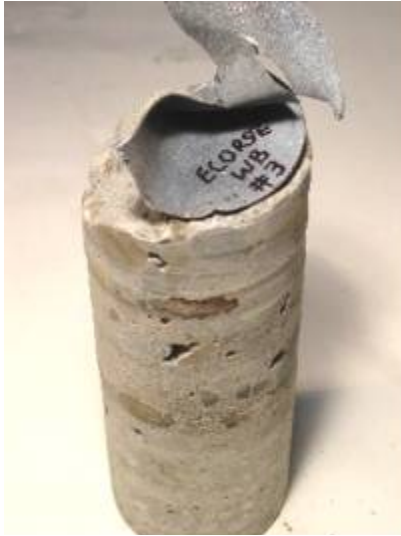
#### Core 9c (Figures 3.150-3.151)

- 9.4 in. height
- Axial section of a steel bar located 3.8 in. from top showed traces of rust.

- The SIPMF separated from the concrete and was damaged during the coring.
- The reinforcing steel had rust traces on its boundary.
- Part of the concrete in the region of the valley of the SIPMF was damaged during the coring.
- Large entrapped air voids of average width 0.3 in. were observed on the surface of the core.

Figure 3.150. Core 9c

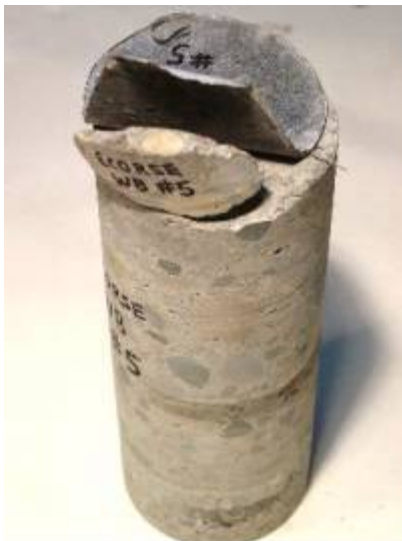
**Core 9e** (Figures 3.154 to 3.156)

- 9.5 in. height.
- The SIPMF separated from the concrete.
- SIPMF had rust traces on the surface that is in contact with the concrete specifically at the location of the voids on the concrete surface.
- Part of the concrete in the region of the valley of the SIPMF was broken during the coring.
- Hairline cracks were observed on the top (surface layer) of the core.

Figure 3.154. Core 9e

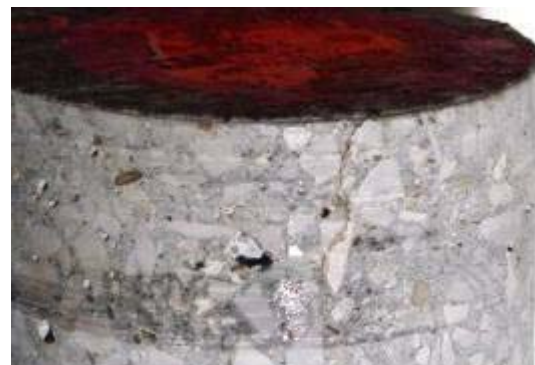
Figure 3.156. Core 9e hairline cracks at the top surface layer of the deck

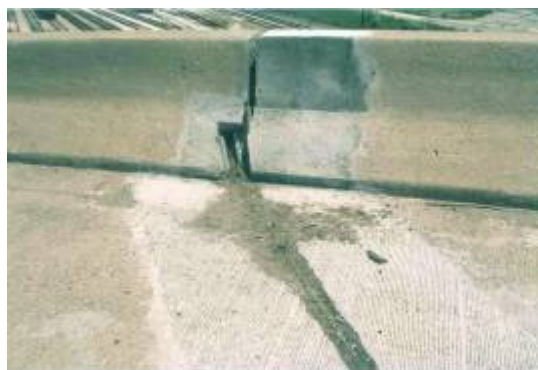
Cracks were observed at the top surface of the concrete slabs. The propagation of cracks was transversely and diagonally across the entire bridge deck as shown in Figures 3.161 and 3.162. Some of the major cracks were found around the joints (Figure 3.163). In some locations the cracks in the parapet were at the same place as in the slab continuing through the entire depth of the deck slab (Figure 3.164). A different type of concrete was encountered at the sides of the joints in the parapet and the top surface as shown in Figure 3.165.

Figure 3.165. Different types of concrete around the joints

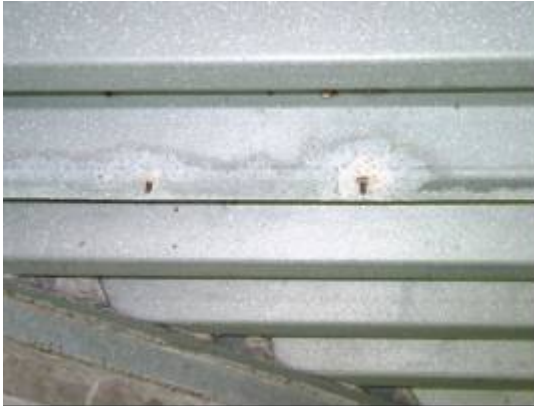
White and rust traces were encountered underneath the deck slab in the SIPMF. Major traces were observed at the overlap between SIPMFs and at the connection between the deck slab and the abutment. The holes where screws were fixing the SIPMF had some of white and rust traces. In some locations, the connection between the steel beams and the SIPMF had white traces (Figure 3.166). The bottom surface of the cantilever parts of the deck slabs had white and rust traces as shown in Figure 3.167.

a. White traces

Figure 3.166. Corrosion and white traces in the SIPMF

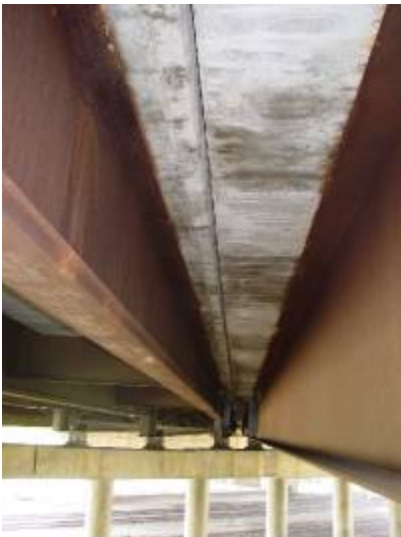
Figure 3.167. Corrosion and white traces on the bottom face of the cantilever slabs

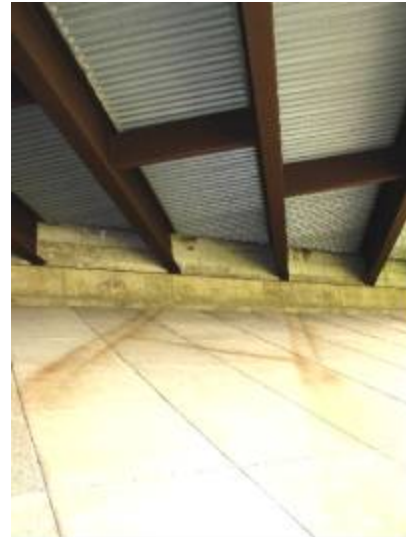
Vertical traces of corrosion were observed on the webs of the steel beams (Figure 3.168). Corrosion and white traces were found at the connection between steel beams and the SIPMF (Figure 3.169). In some locations, major traces of corrosion were found at the connection between the SIPMF and the abutment walls, as shown in Figure 3.170.

Figure 3.168. Corrosion traces underneath the steel beams

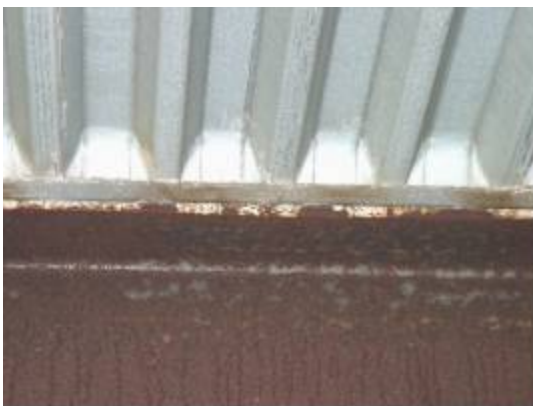
Figure 3.169. White and corrosion traces at the connection between steel beams and the SIPMF

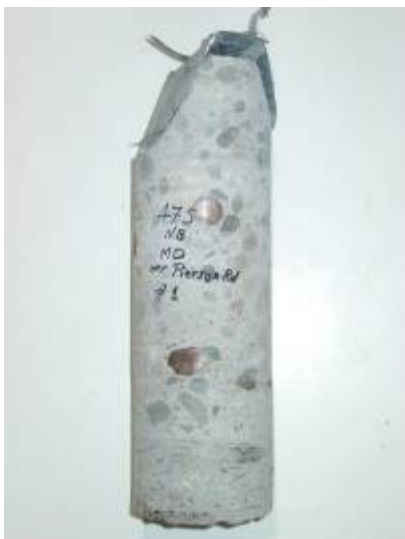
#### **Core 10a** (Figures 3.172-3.175)

- 9.7 in. height (12.0 with the concrete in the region of the valley of the SIPMF).
- The concrete in the region of the valley of the SIPMF was partially broken during coring.
- Six axial sections in the steel reinforcement bar located 4.0, 7.3, and 8.0 in. from top.
- One region of honeycombing of 0.4 in. diameter located 8.3 in. from the top surface.
- Many small voids of average diameter of 0.2 in. were observed.
- One reinforcement bar had minor rust traces while the other did not.
- SIPMF was separated from the core.
- Large horizontal crack was observed at 8.0 in. from top.

Figure 3.172. Core 10a

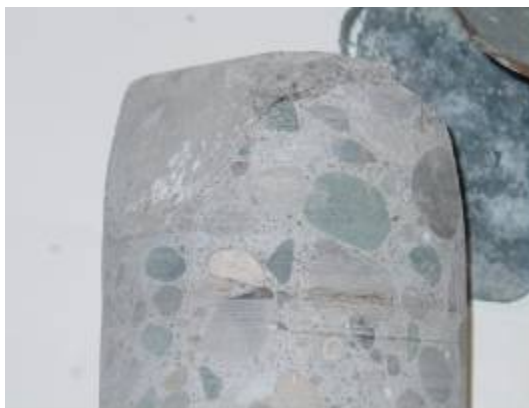
Figure 3.173. Core 10a concrete placed in the valley of the corrugation of the SIPMF partially broken

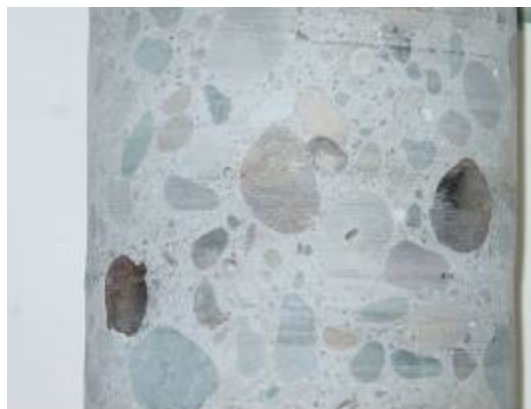
Figure 3.175. Core 10a small voids in the concrete

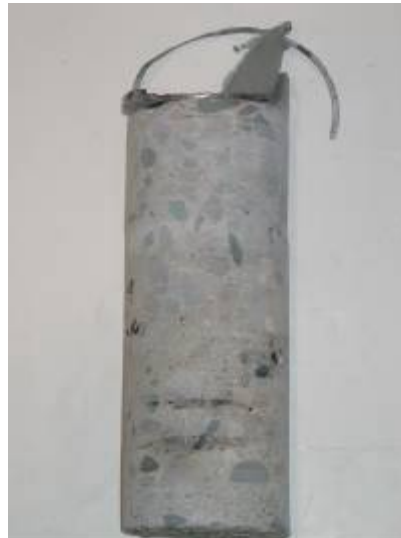
**Core 10c** (Figure 3.177)

- 9.5 in. height (11.0 in. with the concrete in the region of the valley of the SIPMF).
- Many small voids existed of average dimensions 0.2 in.
- SIPMF separated from the core.
- No steel reinforcement bars existed.

Figure 3.177. Core 10c

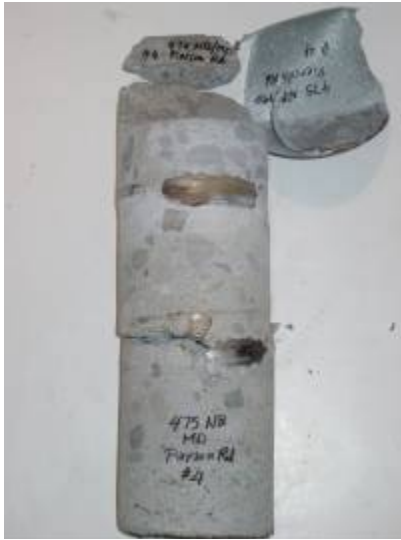
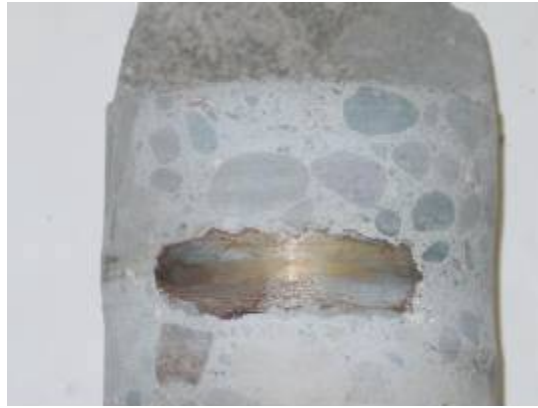
**Core 10d** (Figure 3.178)

- 9.5 in. height (12.0 in. with the concrete in the region of the valley of the SIPMF).

- Two longitudinal cuts of reinforcement bars: one was located 4.3 in. from the top and separated from the core and the other one was located 7.8 in. from top.
- Two axial sections of reinforcement bars located 4.8 in. from top.
- SIPMF separated from the core.
- Many small voids of average diameter of 0.1 in. were propagated at the entire surface.
- Steel reinforcement bars had traces of corrosion.
- Core was broken at 4.5 in. from top at the reinforcement location.
- One large region of honeycombing of 0.5 in. diameter located 3.5 in. from top.
- The concrete in the region of the valley of the SIPMF was broken during coring.

a. Core was broken

b. Reinforcement bar had traces of corrosion

Figure 3.178. Core 10d with corrosion in the reinforcement

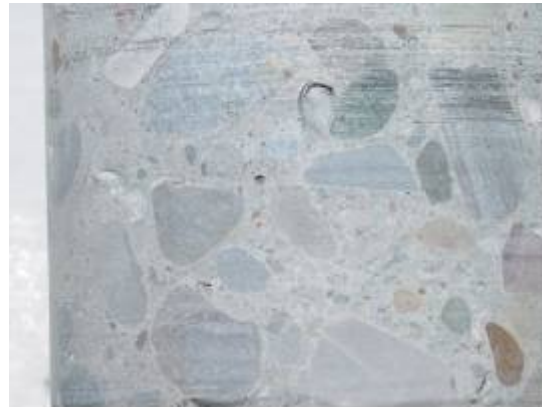
#### Core 10e (Figure 3.179)

- 9.3 in. height (11.5 in. with the concrete in the region of the valley of the SIPMF).
- High porosity in the aggregate and cement paste.
- Many voids of 0.2 in. were observed.
- One region of honeycombing of 0.3 in. diameter was observed 8.6 in. from top.
- SIPMF was separated during the coring.
- One longitudinal cut of reinforcement bar located 4.5 in. from top.
- Traces of corrosion on the exposed reinforcing steel.

b. Region of honeycombing

Figure 3.179. Core 10e with honeycombing

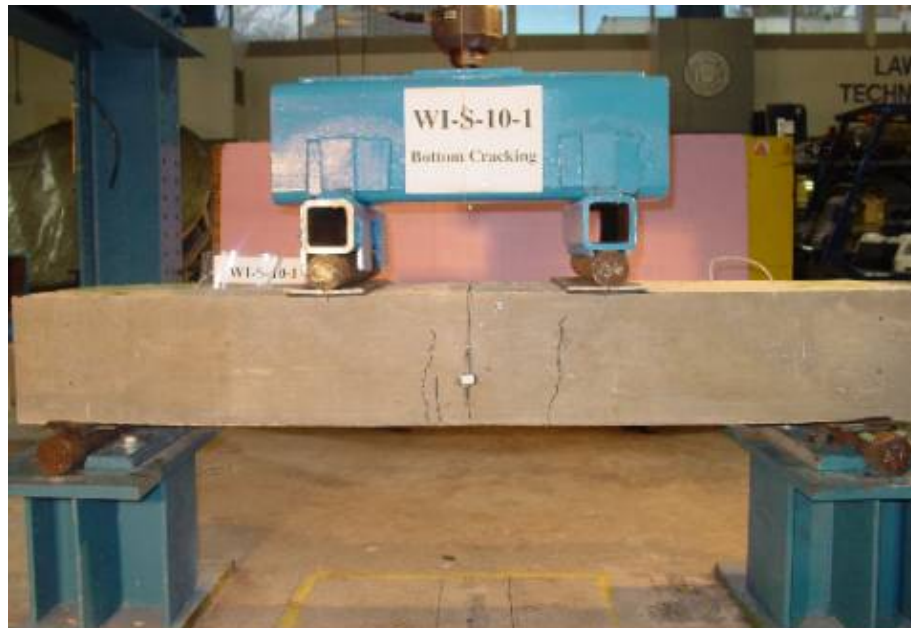
Figure 4.18. Positive moment application  
(cracking along the bottom of specimen with SIPMF)

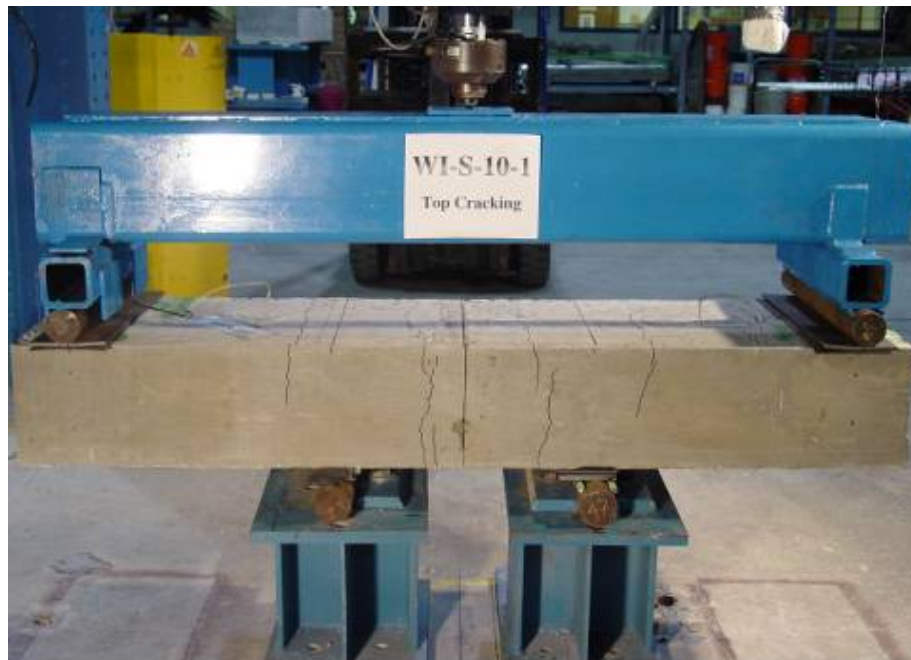
Figure 4.19. Negative moment application  
(cracking along the top of specimen with SIPMF)

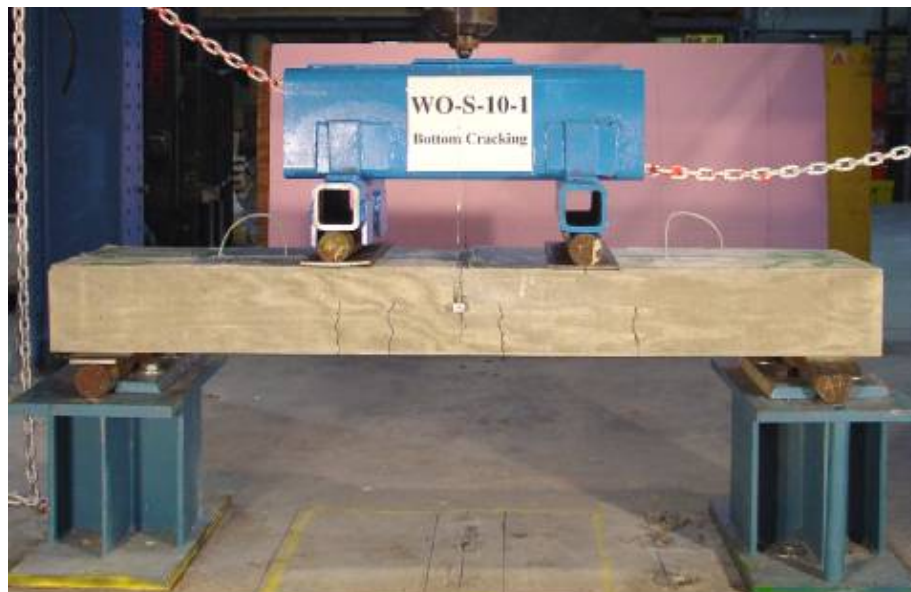
Figure 4.20. Positive moment application  
(cracking along the bottom of specimen without SIPMF)

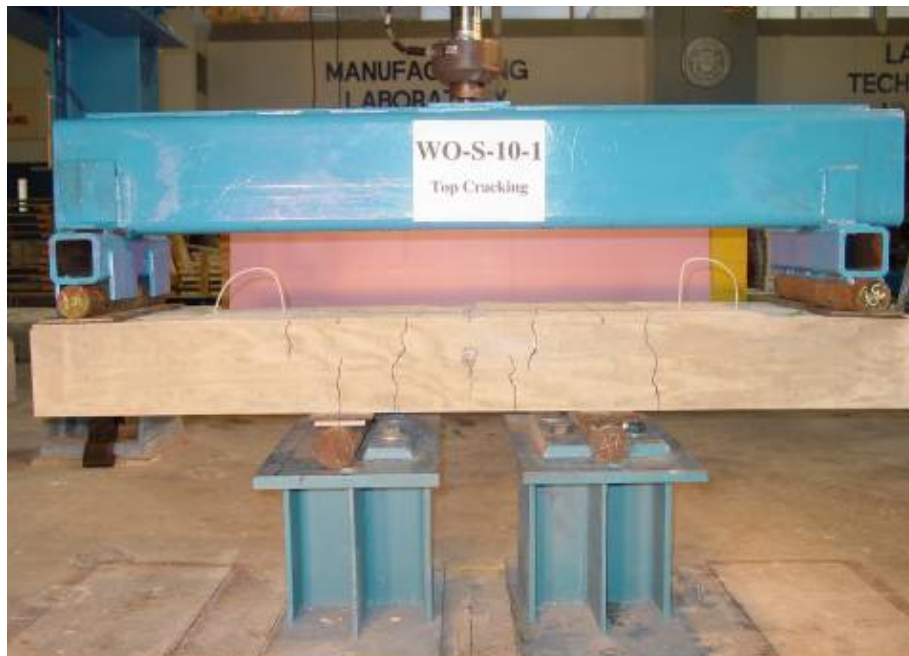
Figure 4.21. Negative moment application  
(cracking along the top of specimen without SIPMF)
